Manhole Inspection Summary

Manhole # S21MM_017MH

Location Address: **1840 CLIFTON-WINDSOR**

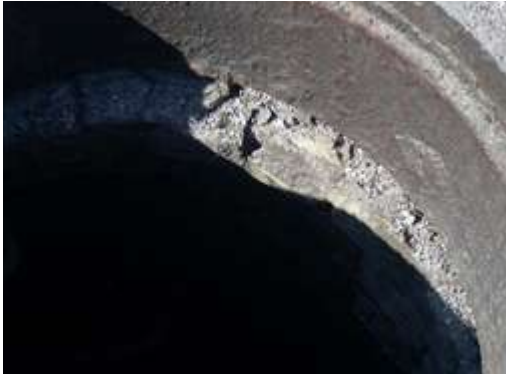
Defect 2

Condition: ☐ Sound ☐ Cracked ☐ Root Intrusion ☐ Loose Brick ☒ **Deteriorated**

DETERIORATION OF CORBEL

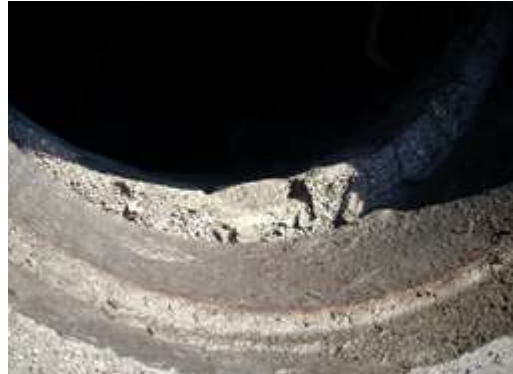
Defect 1

Offset: **2** (in.)

FRAME OFFSET

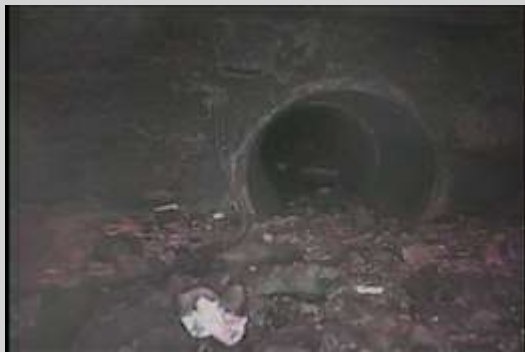
12 O'Clock Outflow

8 in. Circular Gravity Sewer
Pipe Out @ 12 O'Clock

Deposits: ☐ None ☐ Mud ☐ Sludge ☒ **Debris** ☐ Grease

Silt Depth: **2** (in.) Deposits Extent: **Light**
